# A clear path forward for City of Kamloops' most critical feeder main

PipeDiver inspection enables municipality to extend asset life, plan a critical repair and refine capital priorities

City of Kamloops, British Columbia

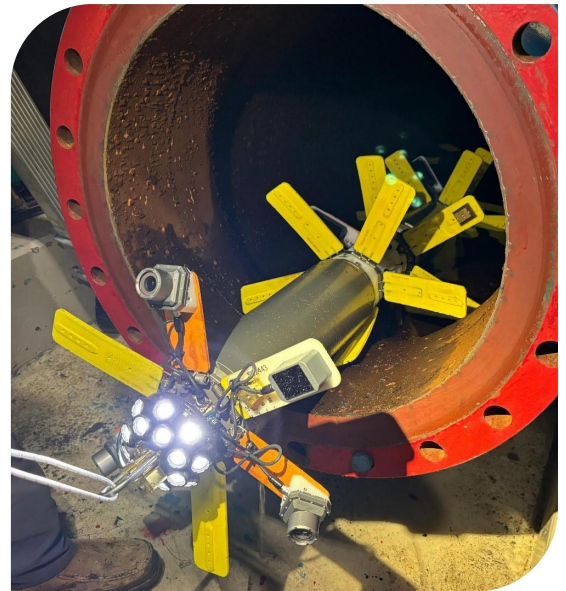
Launching the PipeDiver® platform from City of Kamloops' High Lift Station

Xylem provided turnkey assessment services, including civil and mechanical work to prepare the pipeline for inspection. The team manually inserted the PipeDiver at the High Lift Station, a critical section to inspect given its history of failure and potentially damaging pressure surges. At the extraction point, the team installed a hot tap and isolation valve to remove the tool from the live pipeline.

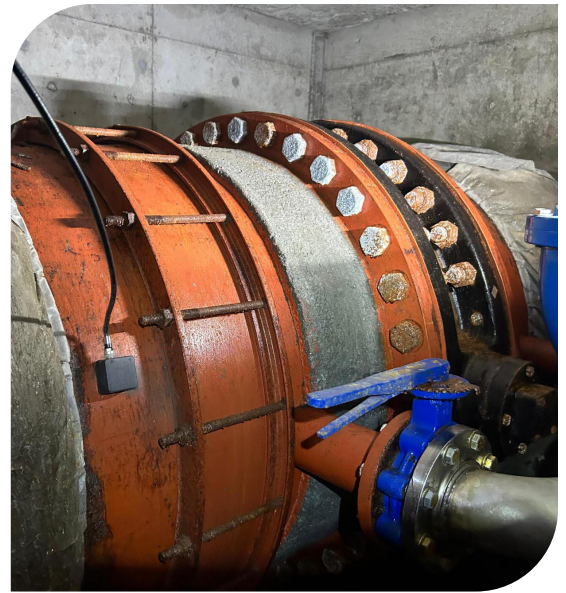
Tracking the free-swimming PipeDiver platform during the 7.7-kilometer inspection

During the inspection, Xylem tracked the tool's progress in real time, enabling the City to perform just-in-time closures at multiple offtakes and keep service interruptions to neighboring areas as brief as possible. The tool passed all six valves and completed the
