Out-of-Round Pipe Emergency Repair

Smith-Blair Tapping Sleeves solve complex infrastructure challenge in residential development

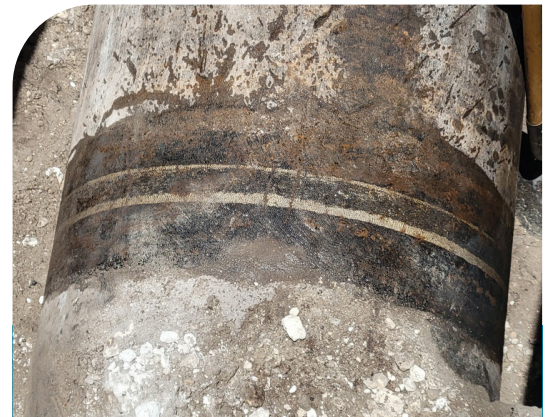
The distributor contacted Smith-Blair who sent a representative to the job site. Using a foam board pipe template, the team confirmed the pipe was slightly out-of-round. This finding initiated a methodical approach to solving the problem.

To obtain precise measurements, plant-manufactured pipe templates were created and shipped to the distributor. These templates enabled the team to take exact pipe measurements using a digital caliper, providing the detailed dimensional data needed for a custom solution.

A second jobsite visit in September proved critical. The team met with the city's engineering department and the project developer to present an alternative solution of using Smith-Blair 624 MJ style tapping sleeves specifically designed to accommodate out-of-round pipe conditions.

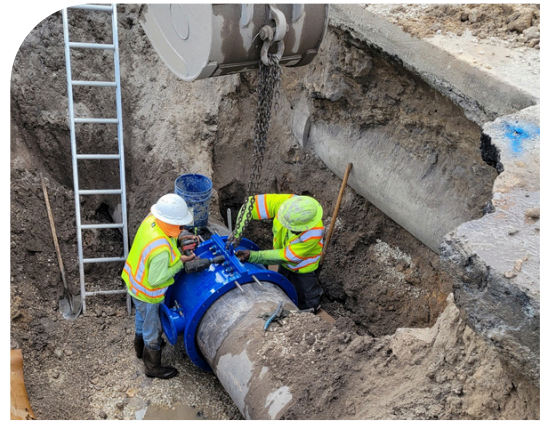
A crew works to install a Smith-Blair 624 MJ style tapping sleeve

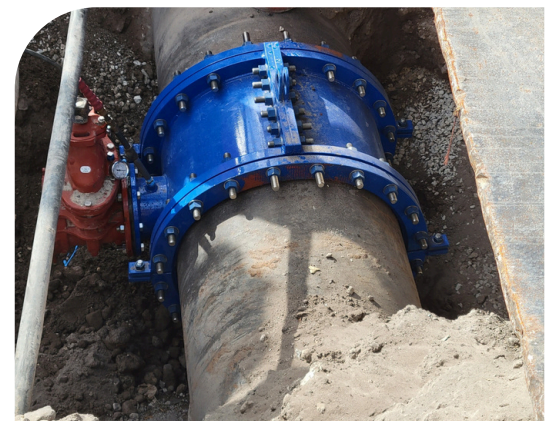
Custom Smith-Blair 624 MJ style tapping sleeve used on this project.

Custom Smith-Blair 624 MJ tapping sleeves engineered to accommodate 5/8" out-of-round variance on 30" ductile iron main.
