Emergency Sewer System Repair

Smith-Blair 675 Split Encapsulating Fitting seals potential catastrophic pipe failure in wastewater infrastructure

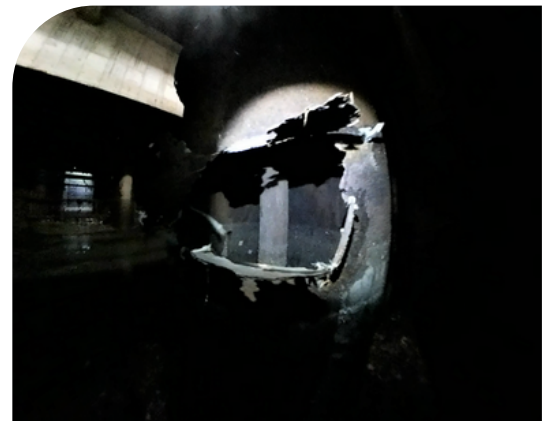
The system's effectiveness depends entirely on the structural integrity of the transfer piping. The city's combined sewage pumping station featured a critical 48-inch carbon steel pipe, installed in the early 1980s, that transferred overflow from the pumping station to retention basins. This pipe was essential to preventing system overload during major storm events. After more than 40 years of continuous service in a highly corrosive environment, the carbon steel pipe developed extensive deterioration. The failure manifested as massive corrosion holes measuring 16 inches by 35 inches, making them large enough to compromise the entire system's functionality.

The 48" carbon steel pipe had 16"x35" corrosion holes that needed repaired.

The city selected the Smith-Blair 675 Split Encapsulating Fitting as the optimal solution for this emergency repair. This specialized product is designed to seal large structural failures in existing pipe without requiring pipe removal or extended system shutdown.

The fitting's split construction allowed installation around the existing damaged pipe without requiring pipe removal, dramatically reducing project complexity and duration. The fitting completely encapsulates the damaged section, creating a new structural envelope that isolates the corrosion holes and restores full system integrity.

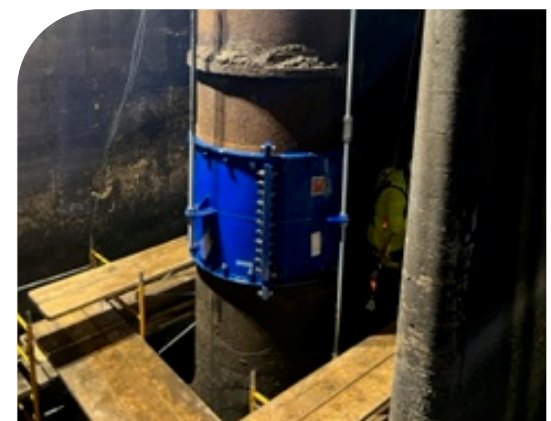
A Smith-Blair 675 Split Encapsulating Fitting was utilized to repair the holes.

The Smith-Blair 675 Split Encapsulating Fitting installation was completed successfully, fully restoring the integrity of the city's critical combined sewer overflow system. The repair eliminated the immediate environmental threat and regulatory exposure while establishing reliable long-term performance.
