# Critical infrastructure repair project

## Smith-Blair adapters solve complex pipe repair challenge and empower proactive inspection

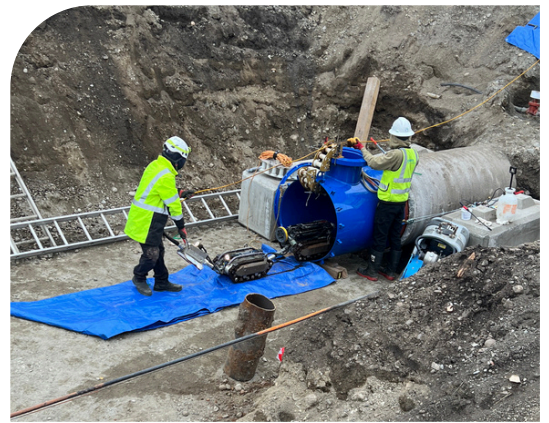
Xylem deploys the PureRobotics platform to inspect the isolated section of the pipeline.

With the line dewatered and access available, the repair created an opportunity to inspect about 3 kilometers of adjacent pipes. Xylem deployed the PureRobotics® platform, which uses a high-resolution camera and electromagnetic technology to provide comprehensive data on the pipeline's internal condition and structural integrity.

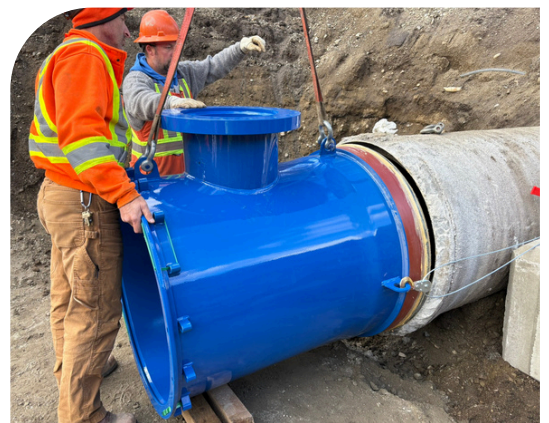
A Smith-Blair 936 is positioned into an existing bell.

The utility planned to replace the at-risk tapping sleeve with a new 36-inch steel pipe section. They selected Xylem's Smith-Blair 935/936 spigot adapters to ensure consistency with the existing PCCP joints. This would create a seamless and uncompromised transition between the existing pipeline and the repair.

However, after excavating the pipeline, field measurements revealed the existing pipe ran smaller than engineering specifications indicated. One connection would be very tight while the other would have excessive clearance.

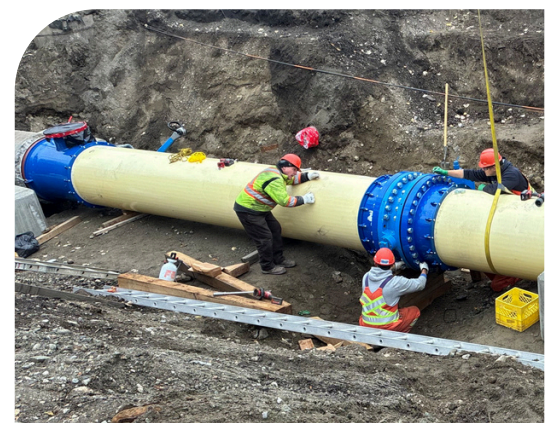
Smith-Blair 935 and 936 spigot adapters and two Smith-Blair 913 coupling assemblies were used on this project.

Additionally, Smith-Blair customized the 935/936 adapters, integrating 16-inch inspection ports on top. These ports were sized and positioned to serve as permanent access points for Xylem's PipeDiver® inspection platform.
